Superfund 1st Five-Year Review Report Smith's Farm Landfill

Brooks, Bullitt County, Kentucky

U.S. Army Corps of Engineers, Louisville District

September 2001

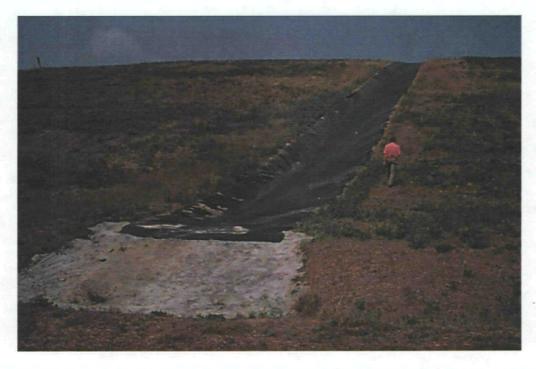
Photo 2 - Typical Lined and Paved Letdown Channel (OU2 Landfill Cap)

Letdown channels descend down the steep south slope which collect runoff by the terraces. These channels are lined, rip-rapped and grouted and in good repair (Photo 2, 17). It was apparent that the shallow channels on the east and west perimeter had recently been repaired and improved (Photos 9, 20,26).

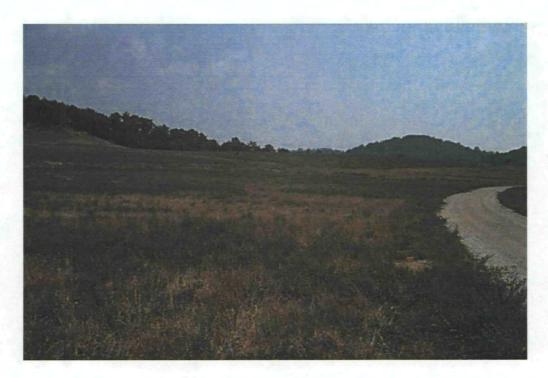
Photo 13 - OU2 Landfill, East View

The cap was observed to be in good condition. The vegetative cover was thorough and relatively abundant (Photos 13, 14). There were several large areas with sparse vegetation (Photo 16), but no woody plants or shrubs were observed.

The entire site is securely fenced, however, two locations along the south perimeter were damaged due to fallen trees. Law said these sections will be repaired as weather conditions improve. Gates are locked and warning signs are posted along the entire chain-link fence alignment and access roads around and on the site are in good condition (Photos 10, 13).

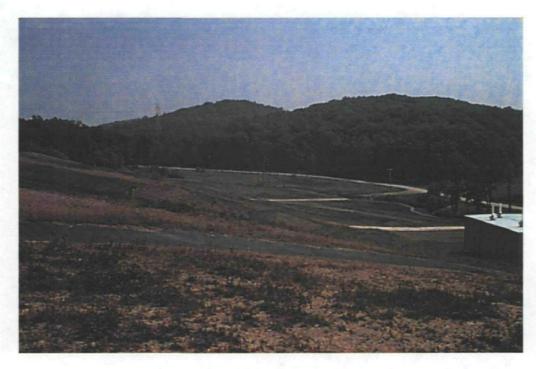
Photo 18 - Landfill South Downslope-Letdown Channel, Interceptor Bench

Due to the slope of the landfill and the strategic location of ditches/terraces (Photo 18), there was no evidence of ponding on the cap. The terraces slow down the velocity and intercept the runoff and directs it to lined letdown channels (Photos 2, 17). There also was no evidence of odent burrowing, cracks or surface erosion. On-site operator indicated that Site Management is notified of any vegetative distressed or eroded sections of the cap and terraces needing repair when they exceed several inches in depth or several square feet in areal extent and repairs are made as part of warranty agreements with a subcontractor by backfilling with equivalent cap material and reseeding with equivalent seed mix, mulching and watering. Repairs are usually pursued on an as-needed basis but usually in the spring or fall to facilitate the necessary revegetation. Since there is on going activity at this site, repairs to the cap are required on a continuing basis. Eroded portions of

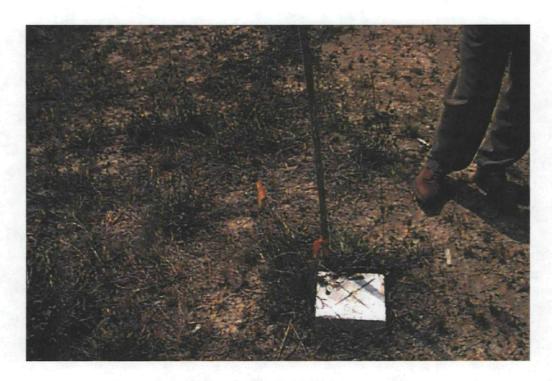
Photo 19 - OU2 Landfill, Typical Survey Monument

There was no evidence of geosynthetics damage over the capped areas inspected and no bulging. No slope instability was visible although some gas vents and protective bollards on the landfill were observed to be tilted (Photo 25). Law explained that vent pipes and bollards were not set during construction specifically for monitoring movement of the landfill cap. Instead, concrete monument bench marks were installed and are surveyed for this purpose (Photo 19).
